Pundit 250 Array Application Booklet

This booklet is intended to illustrate the applications of the Pundit 250 Array instrument. More than that it is intended to be a vehicle that will allow Pundit 250 Array users to share and build their knowledge. This booklet will be updated on a regular basis. If you as a user, have a successful application example that would be of interest to other users or you wish to test a new application, please contact Proceq.

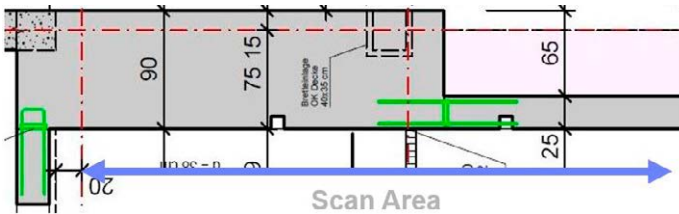
The following example shows how a typical structural assessment can be carried out. In this case, there is a relatively thick section of concrete. The transmission range of pulse echo instruments depends on the quality of the concrete and the amount of reinforcement steel. The current practical range of commercially available instruments is typically around 1m. It can be seen that the structure here is close to that limit.

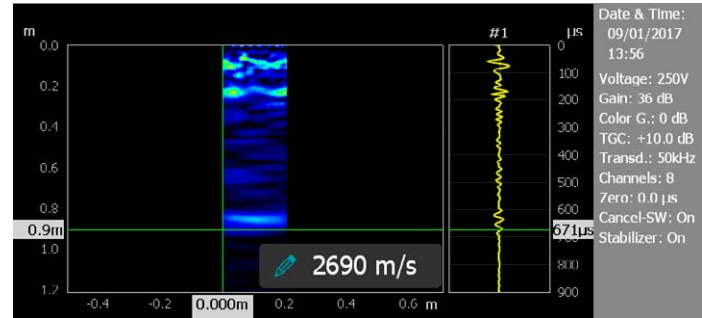
In the B-scan above the back wall echo can be seen at a depth somewhere between 0.8 m and 0.9 m. For ultrasonic pulse echo measurements, depth information is determined by the pulse velocity. For this scan the pulse velocity (2690 m/s) was estimated by measuring surface velocity (Estimate by SW). This is typically the starting point for any investigation and must often be used when access is only available from one side and there is no accurate documentation available on the structure. However, it is well known that the pulse velocity at the surface of a concrete structure can differ significantly from the pulse velocity when measured directly through the structure. According to the literature this difference can be as much as 20 %. Better results can be obtained if the pulse velocity is calibrated at a point on the structure where the actual thickness is known.

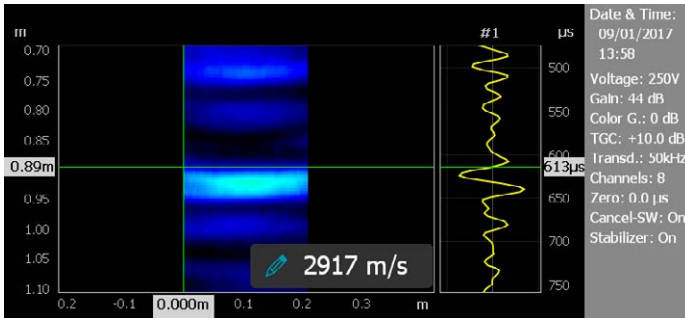
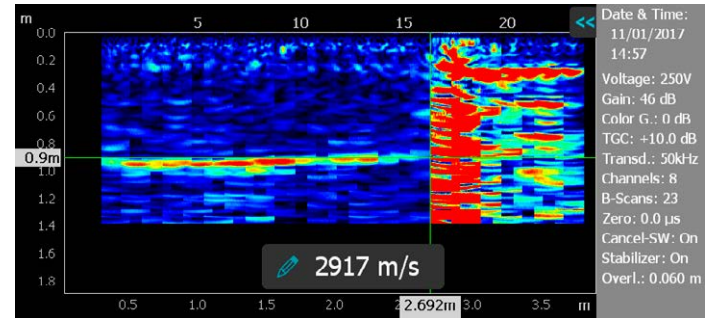
The can above shows a B-scan at the same location after the pulse velocity has been calibrated by measuring at an area of the structure where the thickness is known (Estimate by Echo). The A-scan to the left of the B-scan is used to align the cursor to the beginning of the echo. The difference in pulse velocity from the surface velocity measurement is 227 m/s which resulted in a measured thickness error of about 7 cm or 8 % in this case. This illustrates the importance of pulse velocity calibration if accurate depth information is required. The gain has also been optimized to give a clear back wall signal. These settings can then be used to generate a wide area scan using the panorama B-scan.

This is a scan of around 3.5 m. It consists of 23 separate B-scans stitched together. The overlap is set to 6 cm which is equivalent to two channels. It took less than 2 minutes to generate this scan. After 2.7 m from the beginning of the scan there is a step change in the wall thickness. From here on there are multiple back wall reflections due to the short path length.

The scans above had a relatively high gain and high TGC. This was necessary in order to achieve a strong back wall echo at a depth of 90 cm.

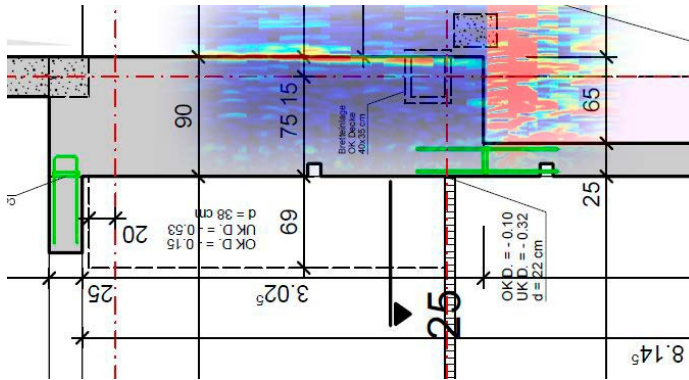
The image below shows how this scan relates to the construction drawings. The wall thickness variations are mapped very accurately.

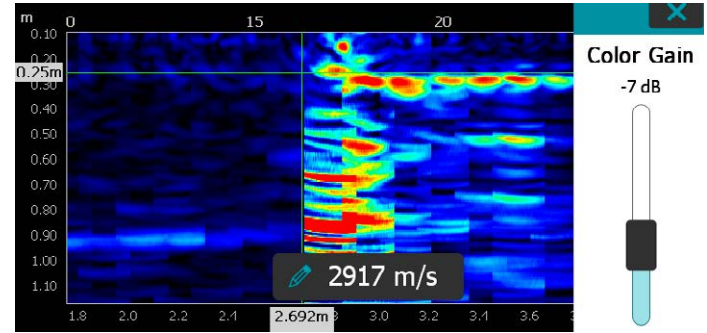
Once a panorama B-scan has been started, it is not possible to change the gain. This can lead to saturation when there are significant thickness changes as we have seen. If we zoom in to the right hand side of the scan where the wall thickness is 25 cm, we can reduce the colour gain to optimize the image in this section during analysis.

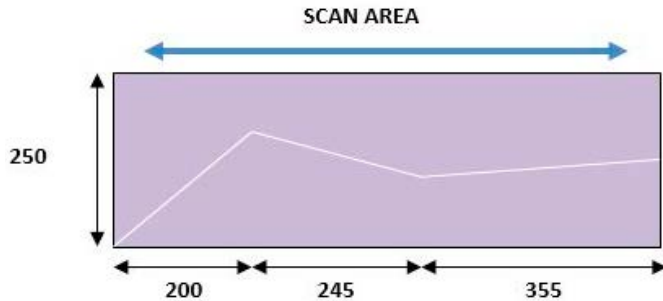
Pulse echo technology is ideally suited to detect delaminations running more or less parallel to the upper surface of the concrete. This example shows a test block 25 cm thick with a zig-zag delamination running through it.

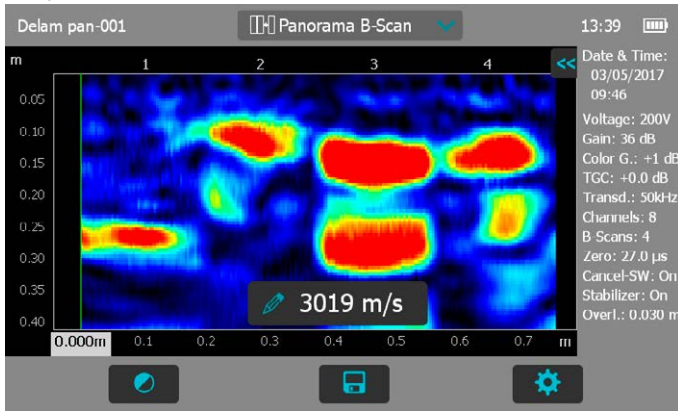
The panorama B-scan of this block is shown below.

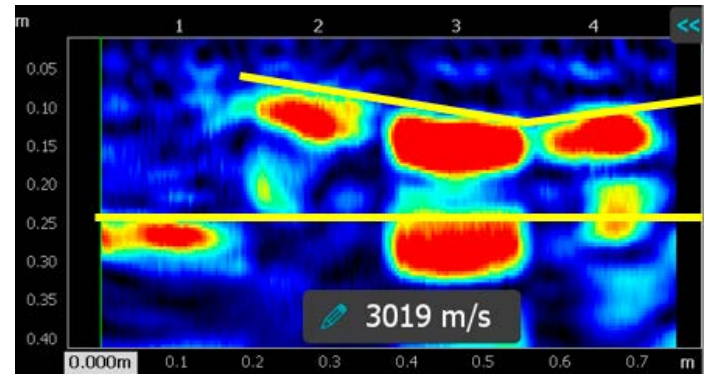
The image below shows how this scan would be interpreted.

The back-wall depth has been marked with a yellow line at a depth of 25 cm. The delamination has also been marked. Below the delamination we see multiple echoes. At the very left, the delamination is too steep to be detected. At a certain angle the echoes are reflected away from the receiver. This is important to understand. Delaminations and cracks can only be detected if they are more or less parallel to the scanning surface.

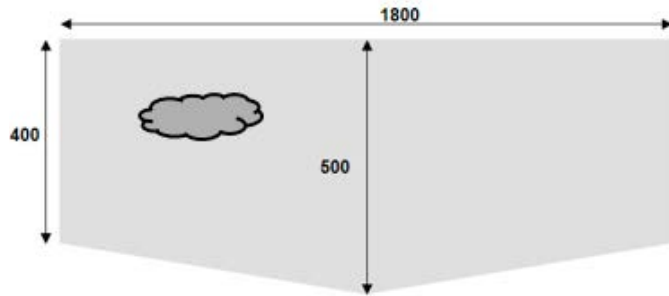
Honeycombing can be detected using pulse echo technology. The ease with which it can be detected and the strength of the echoes received depends on how loose the honeycombing is. Honeycombing with more air content will be easier to detect with stronger echoes. Dense honeycombing on the other hand is more difficult to detect, but can also be considered less of an issue structurally. The image below is a test block with a V-shaped back wall and a honeycomb in the upper left side.

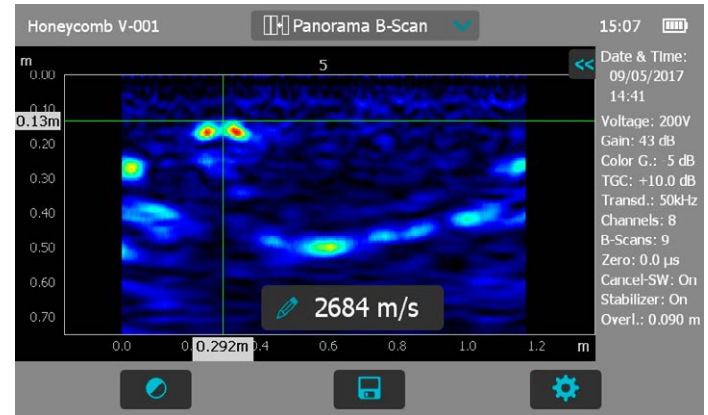
The scan of this test block can be seen here. The thickness variation of the back wall can be traced easily. The honeycombing is loose in this case and can clearly be seen at a depth of 13 cm as indicated by the cross hairs.

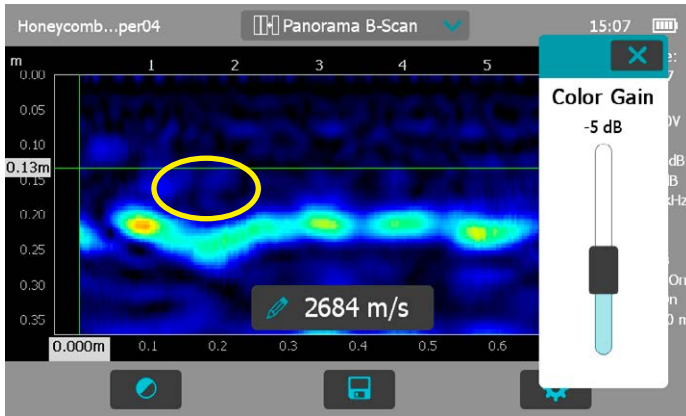
In comparison the scan below is of a test block that is 20 cm thick. It has an area of densely packed honeycombing in the location indicated by the yellow ellipse.

The only indication that there is a defect of some kind here is the deformation of the back-wall echo. This kind of bulge is caused because the object that is present causes the ultrasonic signal to travel a longer path. The object itself though cannot be seen.

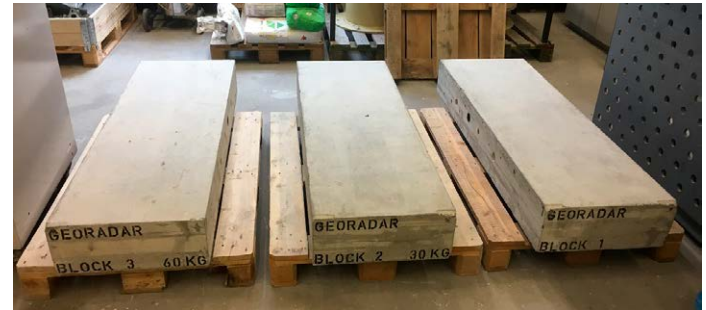
The test blocks shown below are identical except for varying steel fibre content. Test block 1 was constructed with standard concrete with no fibre content. Test block 2 had a fibre content of 30 kg/m³ and test block 3 had a content of 60 kg/m³. Dramix steel fibres 1 x 50 mm were used. The concrete used had a concrete compressive strength class of C25/30 with a maximum aggregate size of 32 mm.

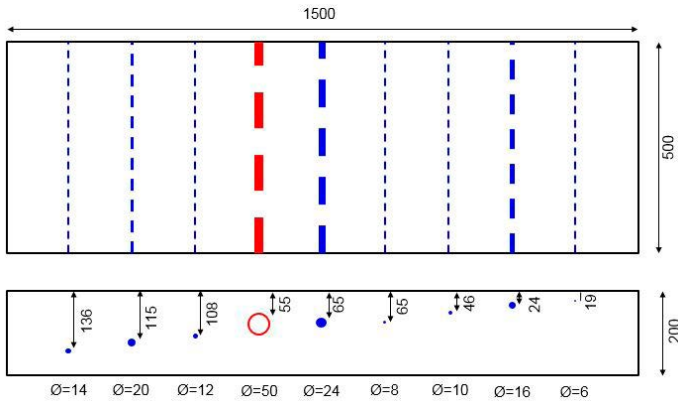
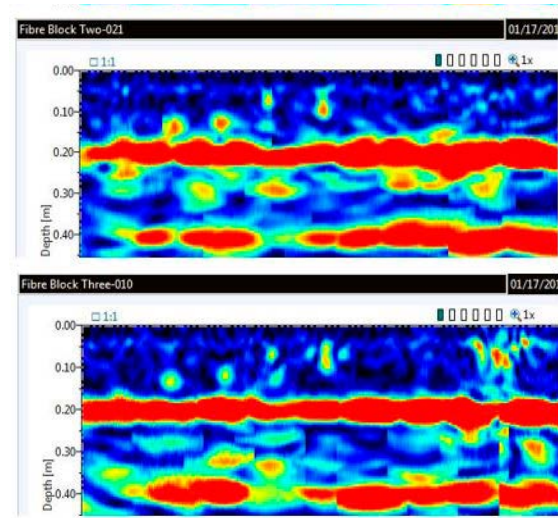
The following panorama B-scans show that the test results are largely unaffected by the amount of fibre content.

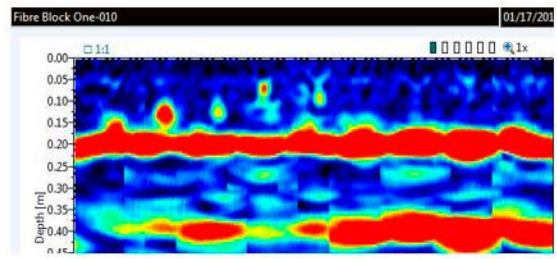
Block 1

The back wall echo can be seen at a depth of 20 cm. The estimate by echo technique was used to calibrate the pulse velocity in this case as the thickness of the object was known. The hollow pipe and the rebars to the left hand side of the block can be clearly identified.

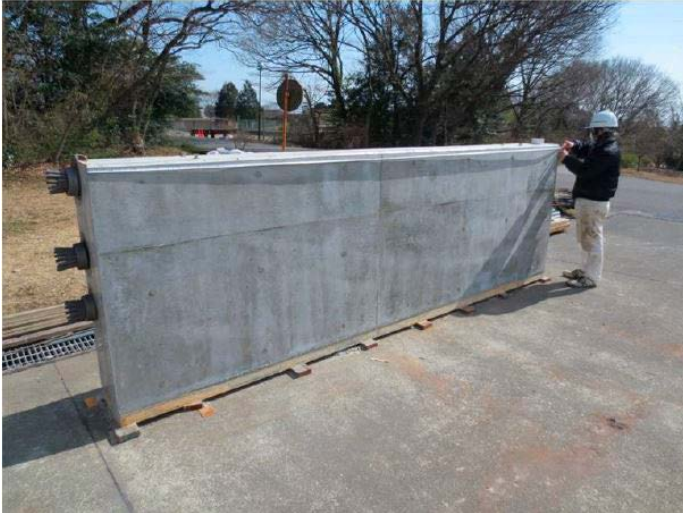
Ultrasonic pulse echo technology can be used to locate tendon ducts and to a certain extent it can be used to investigate the condition of the grouting. Experiments have shown that it is possible to differentiate between the grouted and ungrouted condition by the change in amplitude of the received echoes. The test blocks shown below were created to investigate this.

Rebar spacing: 150 mm
Specimenthickness: 355 mm
Rebar size: D13
Concrete strength: 40N/mm²

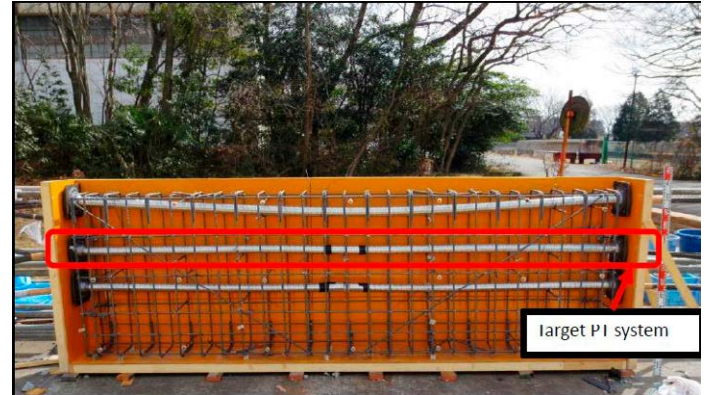
Here we can see the internal structure of the test block. The example is a scan of the middle tendon duct. The details of this PT System:

Stranded wire: (12S12.4 mm)
Sheath diameter: 70 mm
Concrete coverage thickness: 220 mm

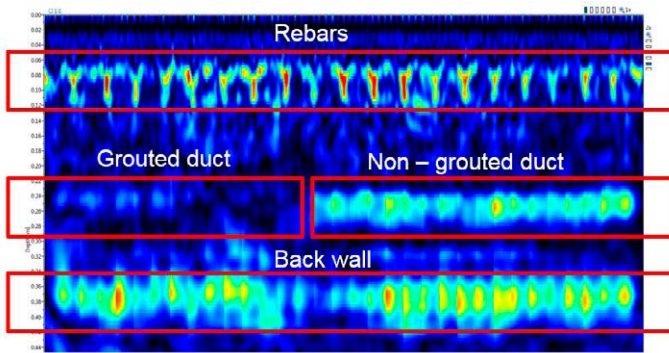
The left hand side of this duct is grouted and the right hand side is not grouted. The scan below shows a span of +/- 1-5 m from the centre.

The back wall echo can be clearly seen at around 35 cm. The rebar grid can be seen at about 7-8 cm.

The PT duct is at a depth of about 25 cm. There are very strong echoes from the PT duct without grout. Where it is fully grouted the echoes are much weaker.
